**Re: Route Permit Compliance Filing: August Status Report and Complaints Summary  
for Hampton-Rochester-La Crosse Transmission Line Project  
PUC Docket No. E002/TL-09-1448**

## Environmental Monitor Monthly Report

**Segment:** Northern Rochester to Alma

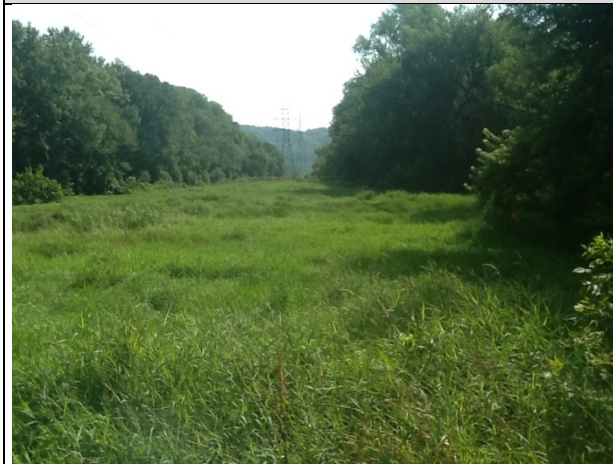
**Photo – 1**

**Description:** This is the wetland near structure 228 prior to construction

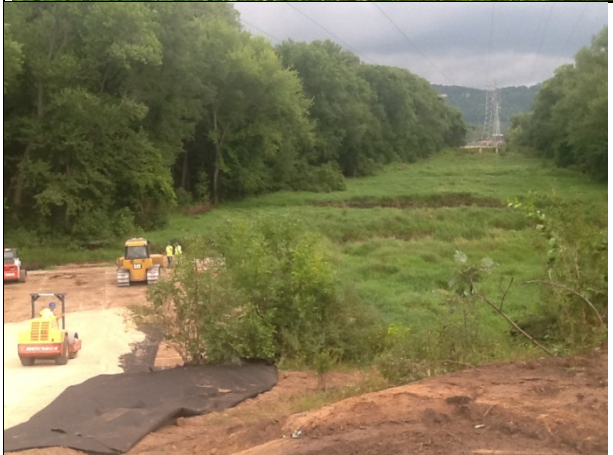
**Photo – 2**

**Description:** Entrance construction and matting placement

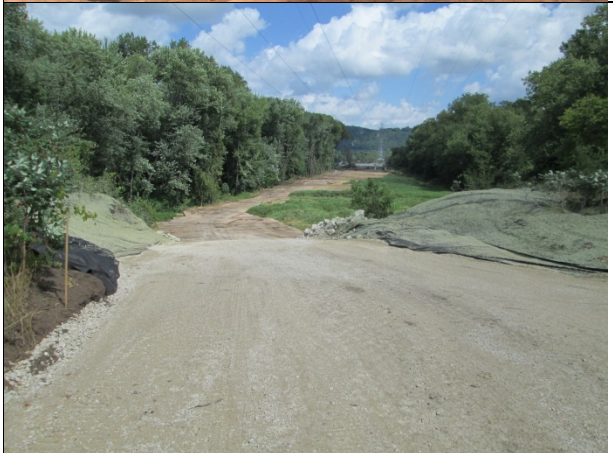
**Photo – 3**

**Description:** Completion and stabilization of peninsula access

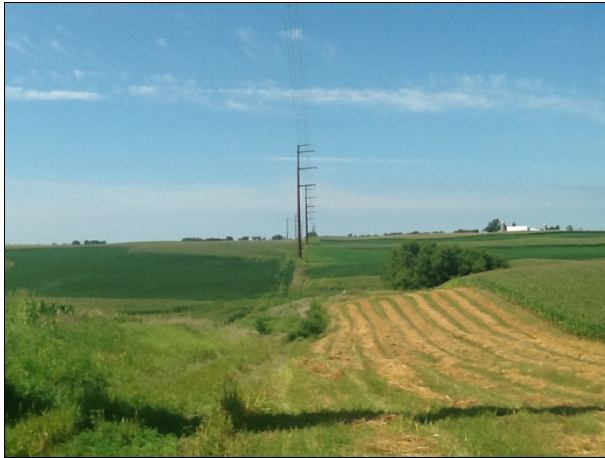
**Photo – 4**

**Description:** Final restoration of 128 looking west

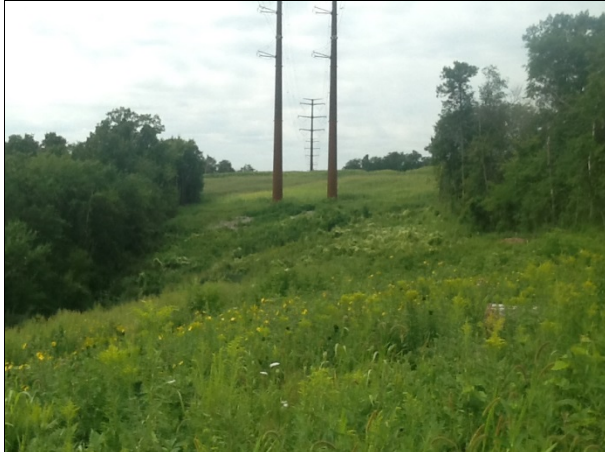
**Photo – 5**

**Description:** Final restoration of 199 looking west

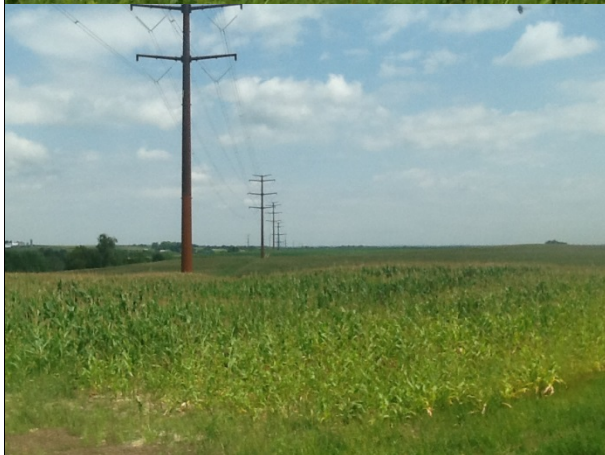
**Photo – 6**

**Description:** Final restoration of 189 looking west

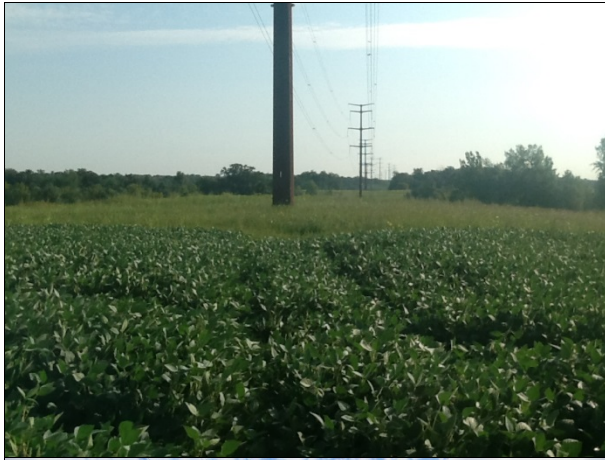
**Photo – 7**

**Description:** Final restoration of 177 looking west

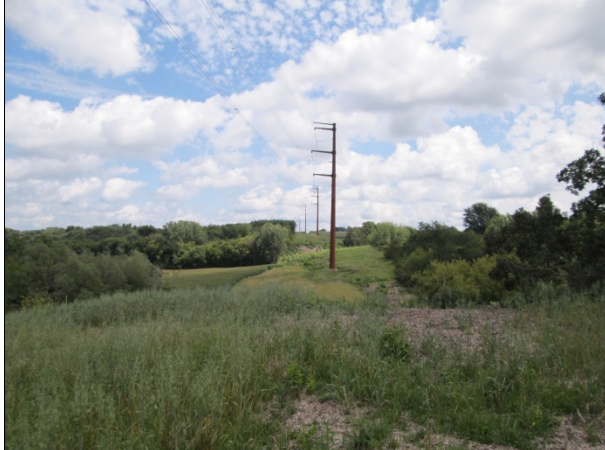
**Photo – 8**

**Description:** Final restoration of 118 looking east

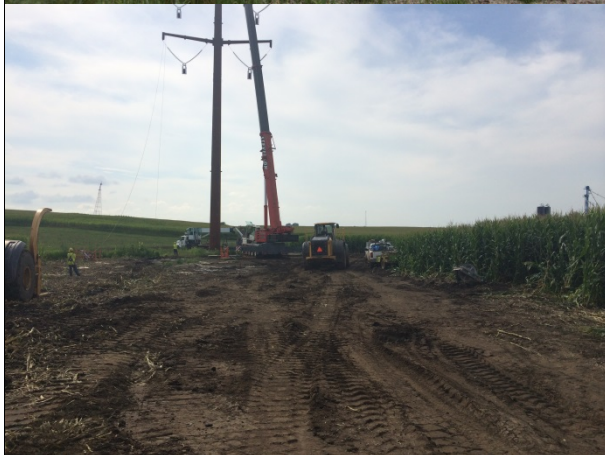
**Photo – 9**

**Description:** Setting of structure 57

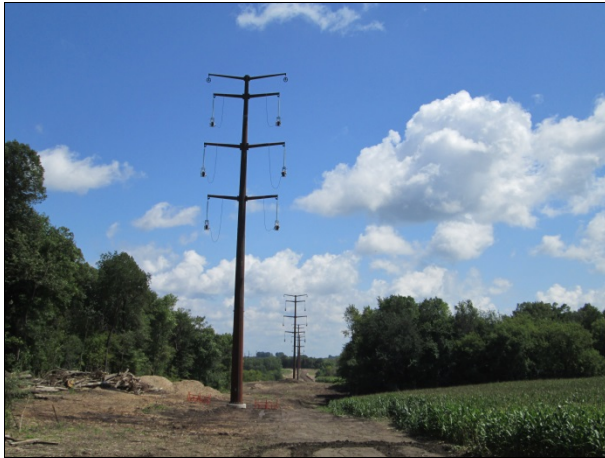
**Photo – 10**

**Description:** Setting of structures 61 looking west

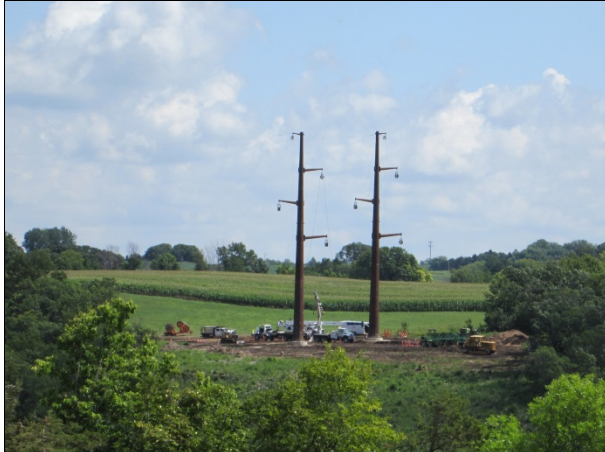
**Photo – 11**

**Description:** Setting of structure 67 where the line crosses the Zumbro River

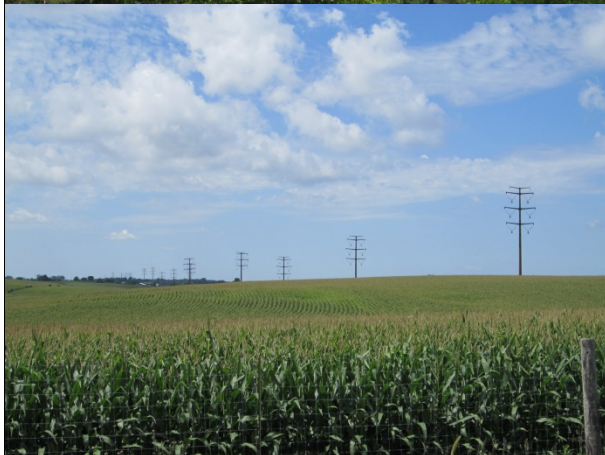
**Photo – 12**

**Description:** Long view of newly set structures looking west

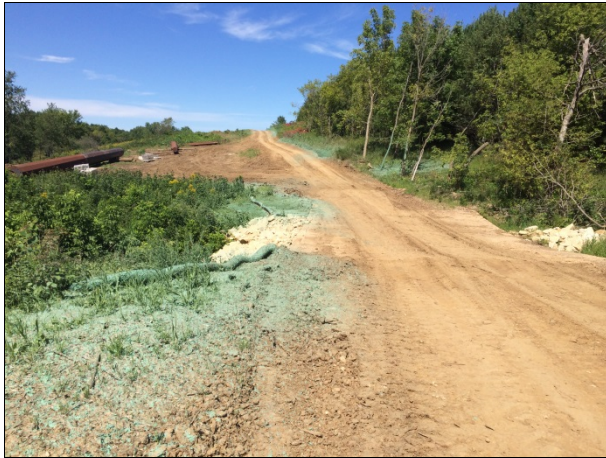
**Photo – 13**

**Description:** Dahn continues to come in and Stabilize until work resumes in this area

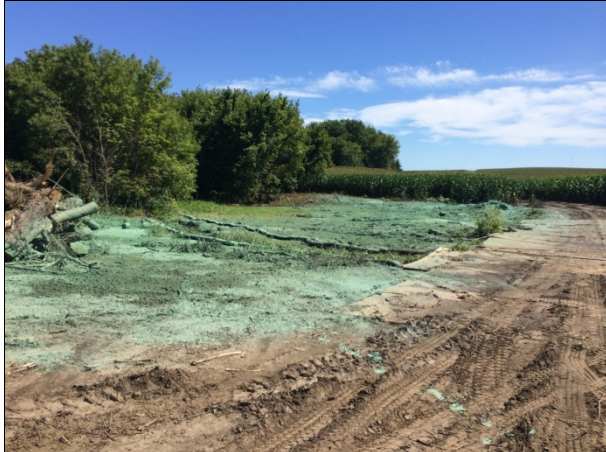
**Photo – 14**

**Description:** Dahn hydroseeded cleared area for stabilization along access and near stream

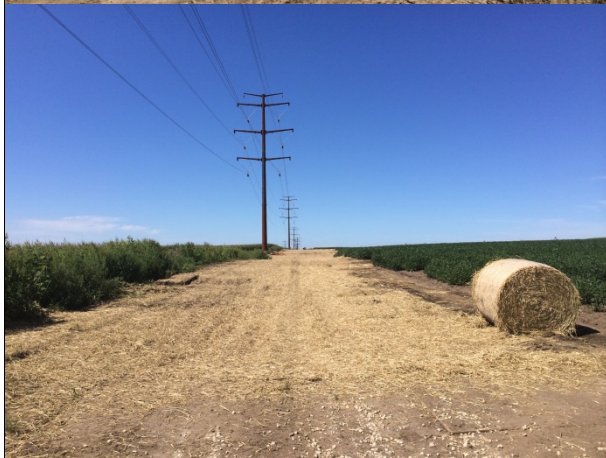
**Photo – 15**

**Description:** Dahn has seeded entire ROW with seed and covered with straw for temporary stabilization

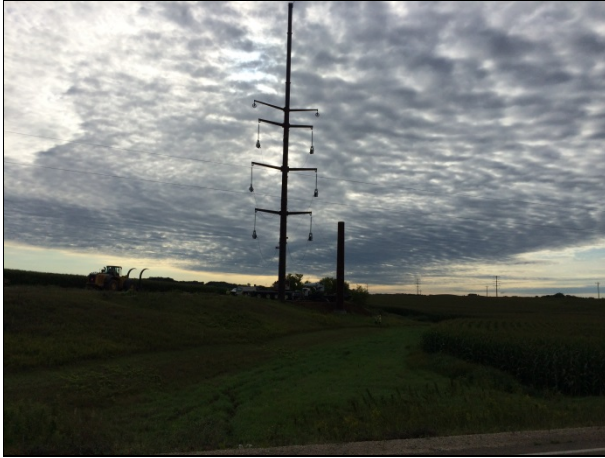
**Photo – 16**

**Description:** The setting of structure 51
