**Re: Route Permit Compliance Filing: December Status Report and Complaints
Summary for Hampton-Rochester-La Crosse Transmission Line Project
PUC Docket #TL-09-1448 and the North Rochester to Chester 161 kV
Transmission Line Project PUC Docket #TL-11-800**

Environmental Monitor Monthly Report

Date: December 31st, 2015	Location: Olmsted and Goodhue Counties
Environmental Monitor(s): Andrew Welch, Andrew Wendlandt, Sarah Duke Middleton	Segment: Hampton to North Rochester
Contact #: (608) 807-9806	Site Conditions: Temperatures varied greatly throughout the month, ranging from 9 – 47 degrees F. Mild weather resulted in a rain event mid-month, and several storms dropping a wintry mix (snow/rain/ice) across the project. The ROW (Right-of-Way) remained saturated for a large portion of December, and began to freeze at the end of the month. Approximately 6-8 inches of snow covered the ROW by the end of December.

Date: December 31st, 2015	Location: Olmsted and Wabasha Counties
Environmental Monitor(s): Andrew Welch, Andrew Wendlandt, Sarah Duke Middleton	Segment: Northern Rochester to Chester
Contact #: (608) 807-9806	Site Conditions: Temperatures varied greatly throughout the month, rang

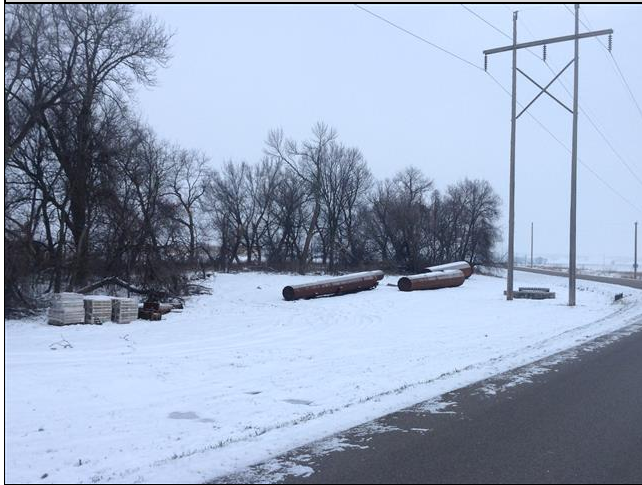
Photo – 1

Description: Hauling crew has been delivering structures as soon as they come into the laydown yard. These structures were spotted in a wetland on top of cribbing. Matting will be needed to set the structure or the ground is frozen.

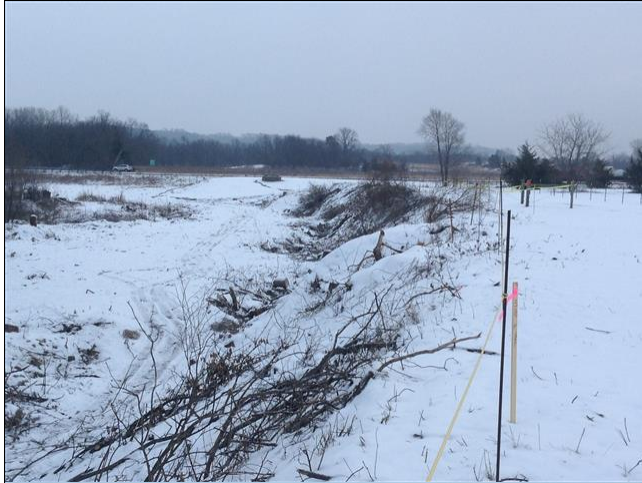
Photo – 2

Description: Slopes are stable after tree removal.

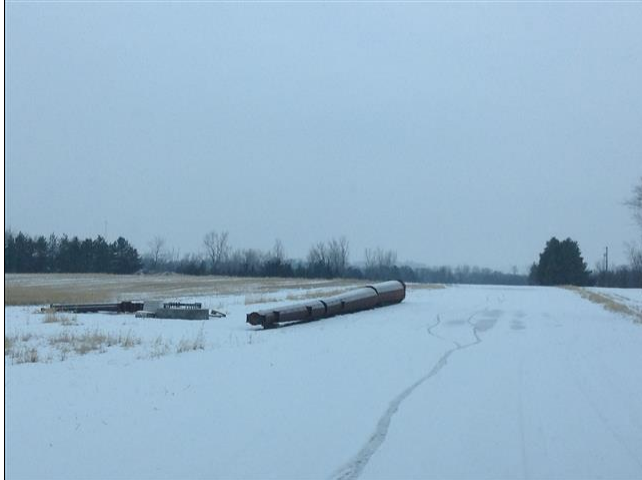
Photo – 3

Description: Stable ROW with snow cover, minimal vehicle traffic, and vegetation intact surrounding ROW.

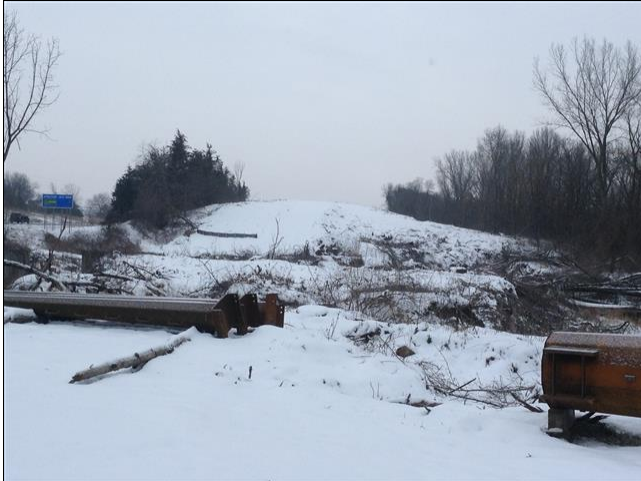
Photo – 4

Description: Slopes are stable with BMPs in critical area in place.

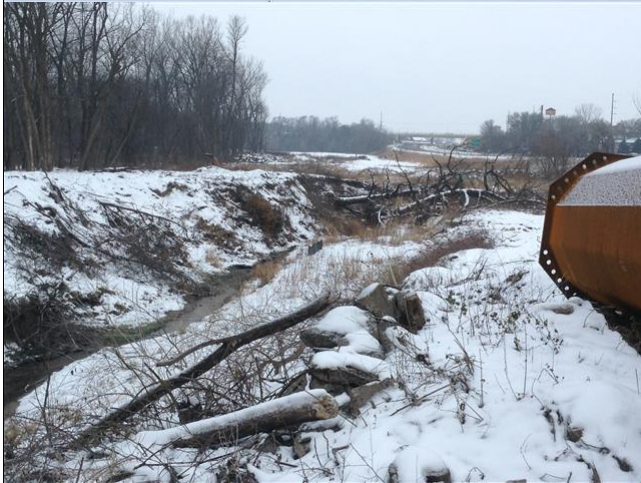
Photo – 5

Description: Slopes surrounding stream are stable following clearing.

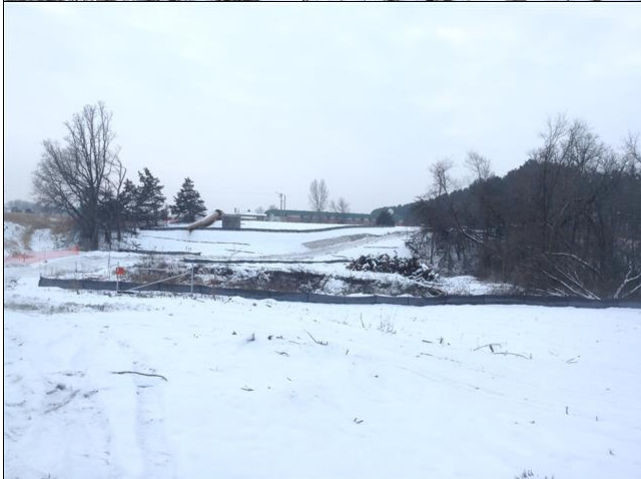
Photo – 6

Description: BMPs surrounding stream area stable with minimal vehicle movement.

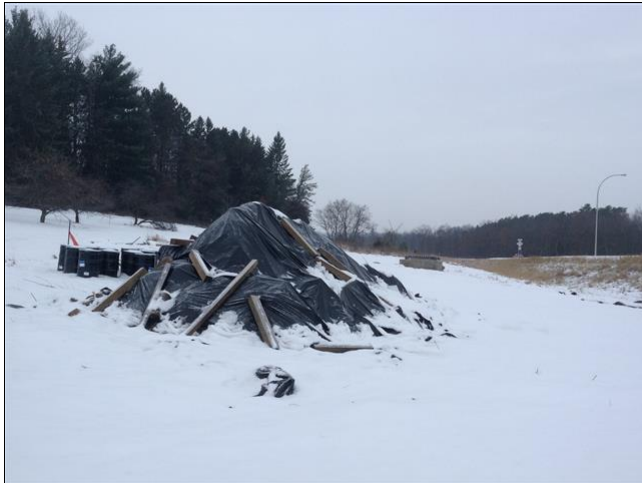
Photo – 7

The major issue of note on the ROW is still the landowner spill that occurred in October 2015 at structure 81. On October 30th, Clean Harbors excavated the remaining contaminated and placed the soils onto poly tarp for control. The contaminated soils were then covered up with additional poly tarp for protection. The liquid waste retrieved was placed into 50 gallon drums, also located on the ROW. At the end of the December Clean Harbors had yet to return and finish the cleanup process. Construction crews were able to conduct work on the ROW and avoid this area.

Description: Clean Harbors hasn't removed sediment from site at this time. Both the 55 gal drums and pile are on site awaiting resolution.

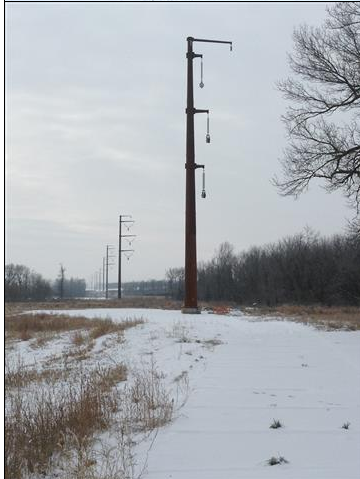
Photo – 9

Description: ROW conditions are stable with frozen soils and several inches of snow cover. Vegetation is in place along ROW.

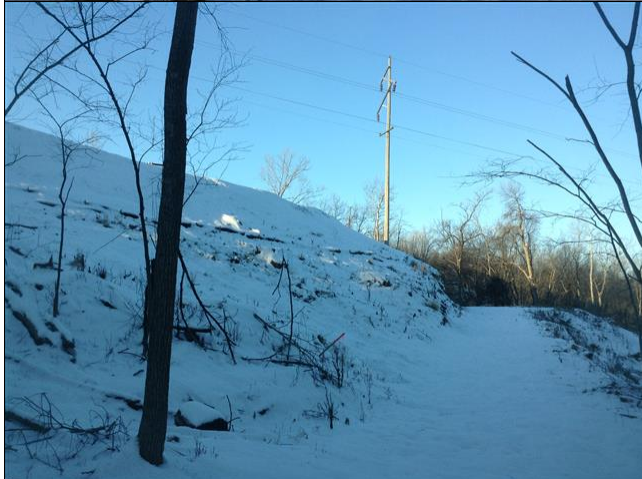
Photo – 12

Description: Slopes remain stable and BMP's in place.

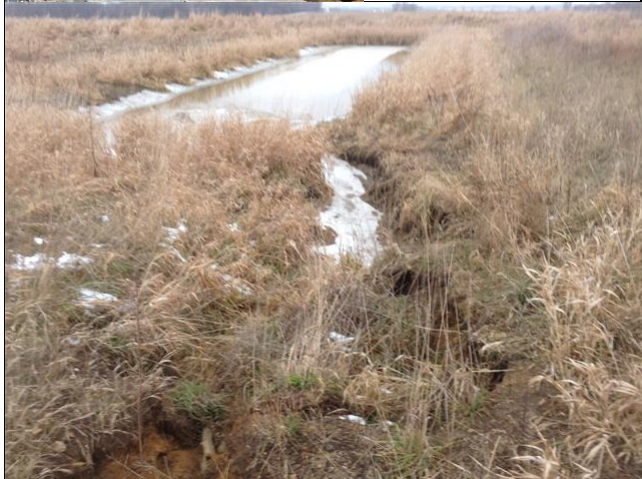
Photo – 15

Description: Water channeled from access road above infiltration basin and around the culvert leading into it near substation. Sediment was deposited into infiltration basin. A cleanout of the basin and restoration of channel will occur next spring.

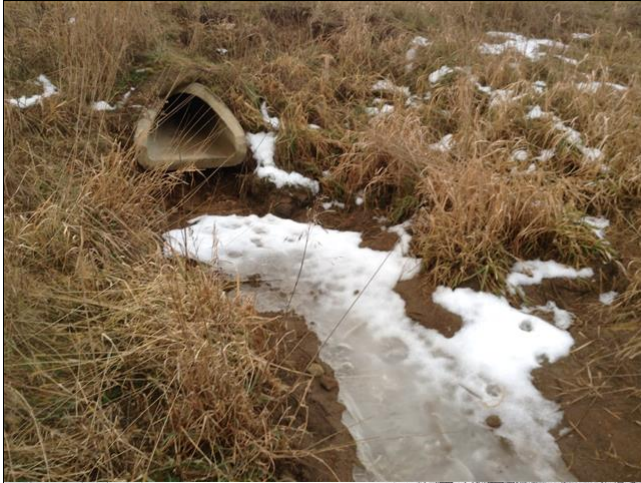
Photo – 16

Description: Additional view of infiltration basin issue.

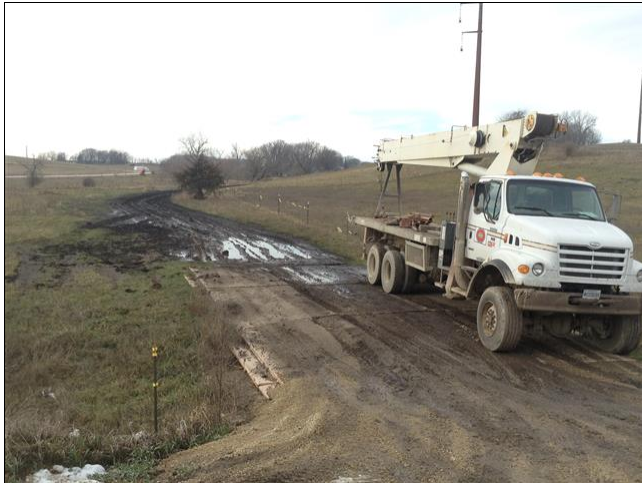
Photo – 22

Description: Mud and rutting on matting from vehicle traffic.

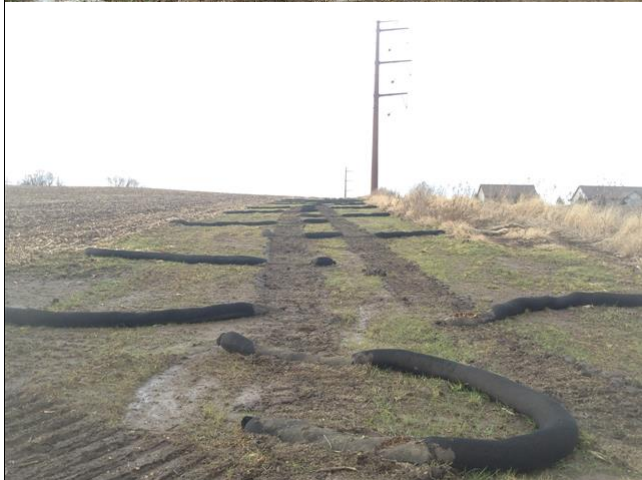
Photo – 23

Description: Damaged biologs from vehicle access to structure. Additional biologs were placed on the slope by Dahn to minimize soil movement.

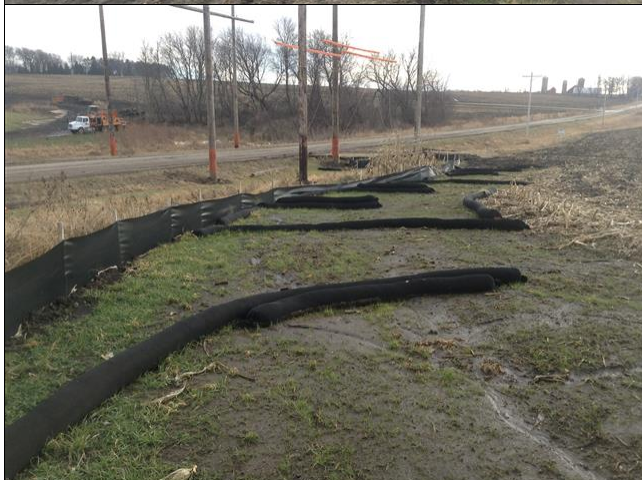
Photo – 24

Description: Vegetation growth and a combination of biologs and silt fence are holding up on access.

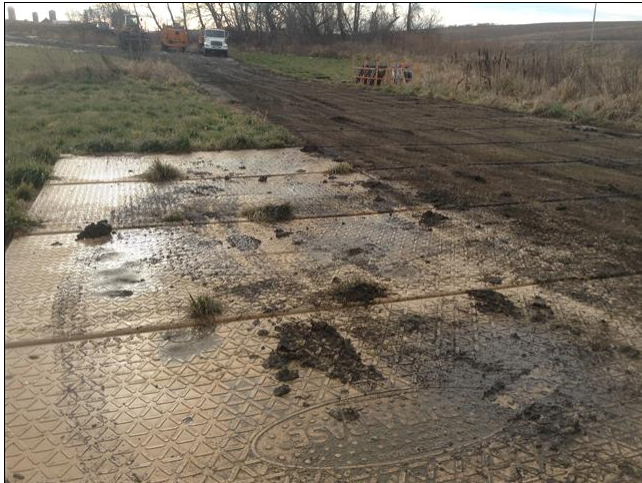
Photo – 25

Description: Mud tracking on matting from crews working and leaving ROW.

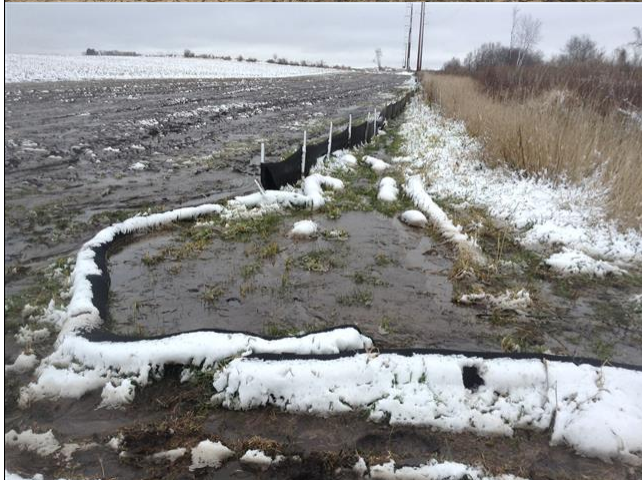
Photo – 26

Description: BMPs functioning as designed. Holding back sediment and controlling water flow away from wetland.

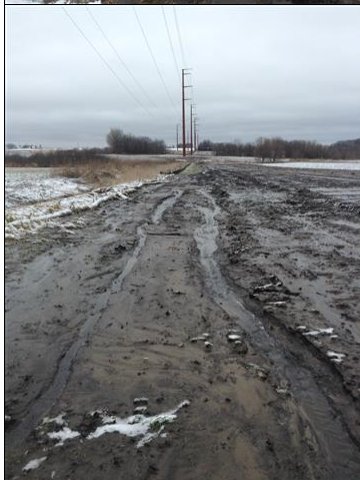
Photo – 27

Description: Snowmelt run-off channeled sediment down slope, but not off the ROW.

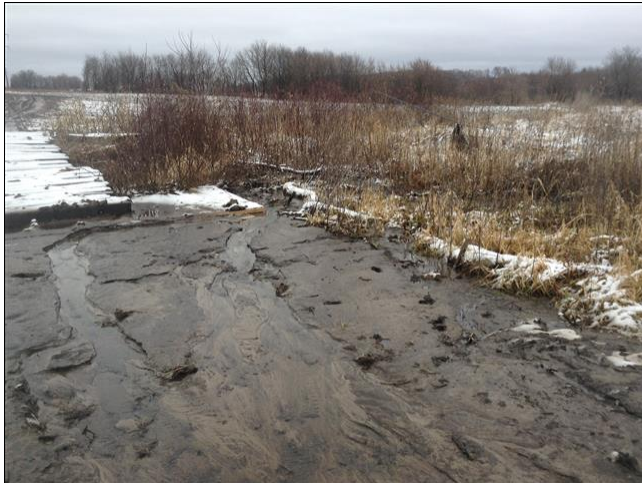
Photo – 28

Description: Matting over wetland was removed and BMPs not replaced leading to sediment channeling through area and depositing in wetland.

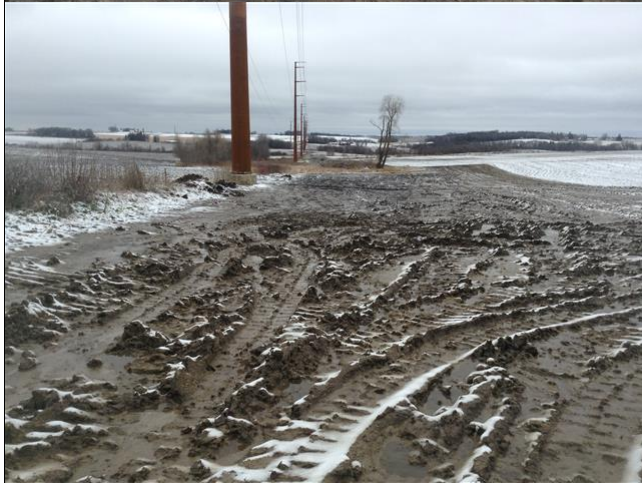
Photo – 29

Description: Site conditions; rain, snowmelt, and muddy soils led to areas of rutting but not much sediment movement.

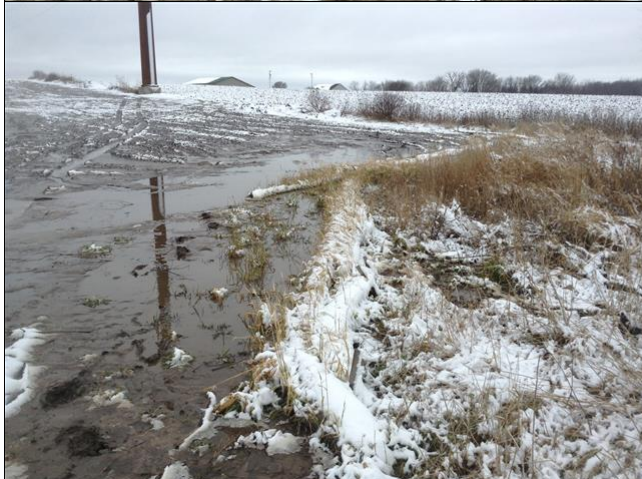
Photo – 30

Description: BMPs performing at designed. Withholding sediment movement and allowing water infiltration.

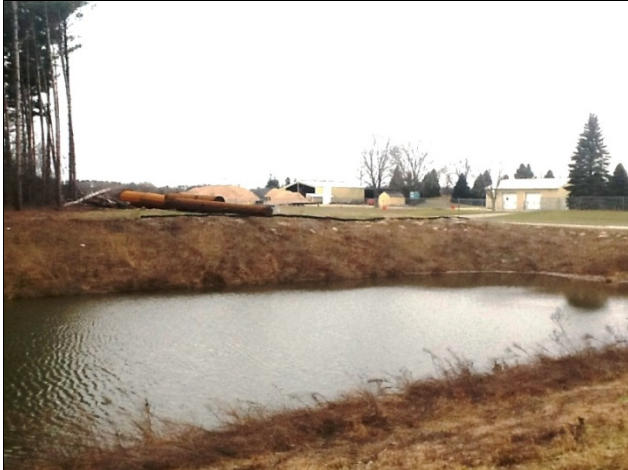
Photo – 31

Description: BMPs protecting infiltration basin.

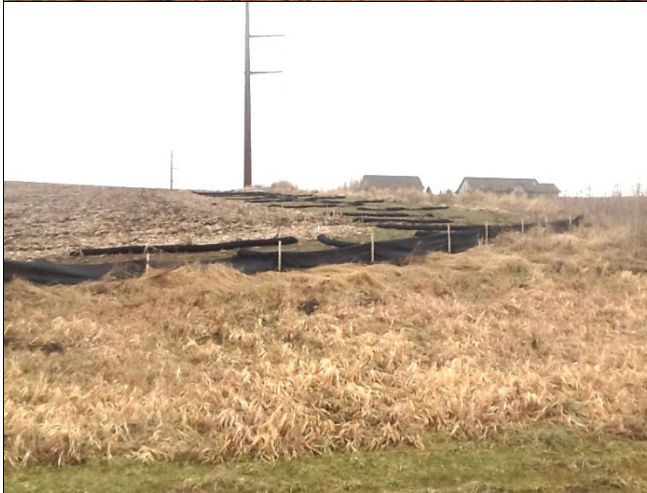
Photo – 33

Description: BMPs stabilizing hillside (silt fence, numerous biologic checks, and vegetation).

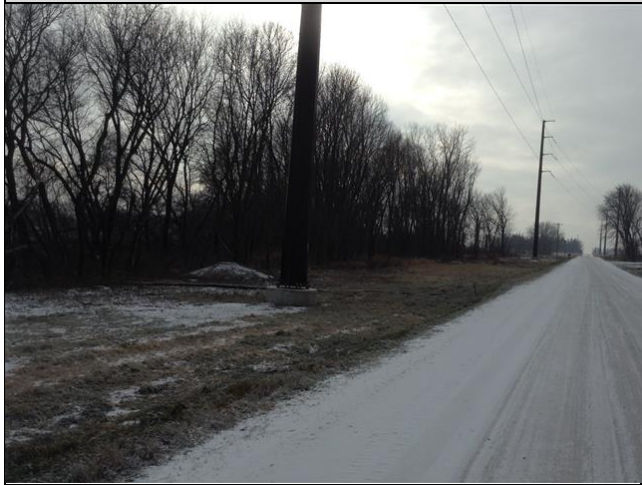
Photo – 1

Description: (ROW) Right-of-Way is stable and remains heavily vegetated with ECDs (Erosion Control Devices) in place for stabilizing soils or protecting wetland areas.

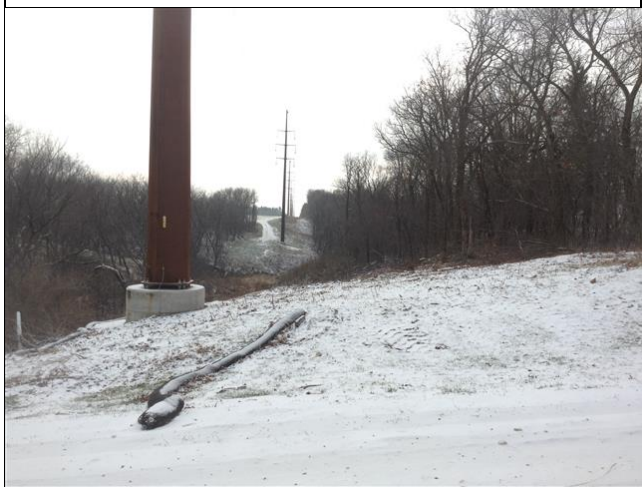
Photo – 3

Description: Dahn placed ECDs after restoring slope, seeding, and blanketing once crews finished setting structure and prepping for wire pull.

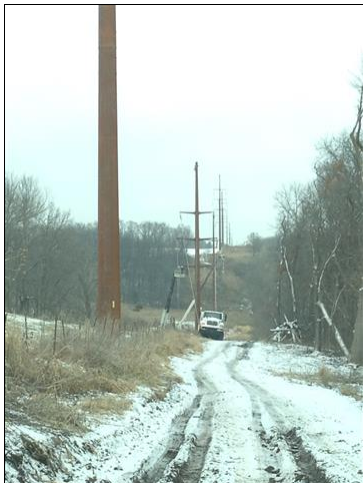
<p>Photo – 4 Date: 12/2/2015</p> <p>Location: STR 182</p> <p>Description: Crews conducting wire pull operations. Slopes are not showing any sediment movements and BMPs are in place.</p>

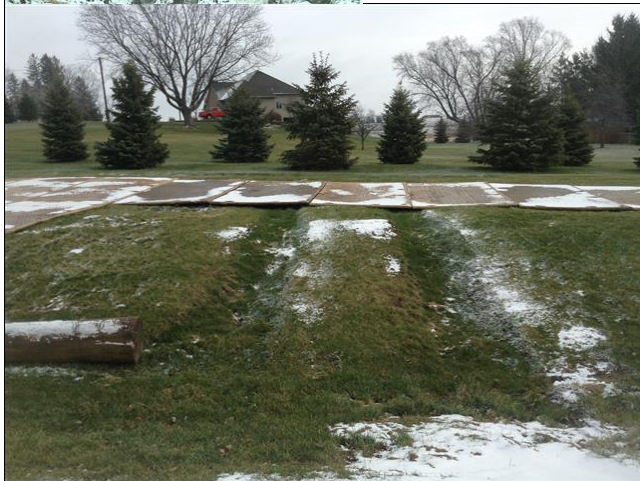
<p>Photo – 5 Date: 12/2/2015</p> <p>Location: STR 189</p> <p>Description: Crews are working on matting as much as possible to minimize rutting and compaction issues such as this example.</p>

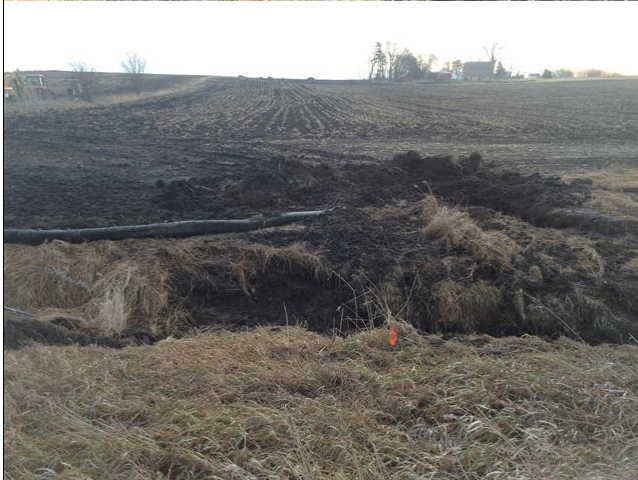
Photo – 8

Description: Landowner tiled field and connected it with existed waterway/wetland area. In the process of excavating drainage he damaged the project's biologs and protection. Sediment is piled within wetland and directly on top of biologs.

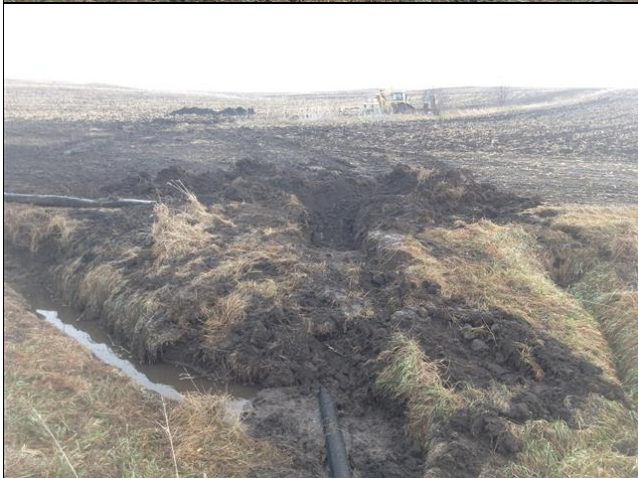
Photo – 9

Description: Additional photo of landowner damage to wetland/project controls.

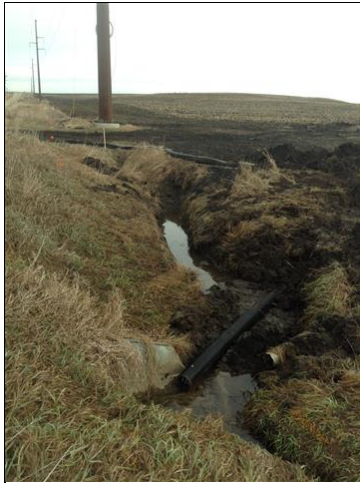
Photo – 10

Description: Additional photo of landowner damage to wetland/project controls.

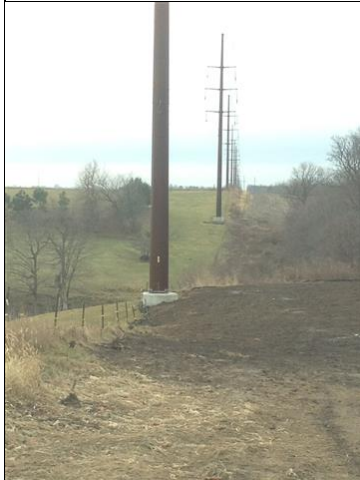
Photo – 11

Description: Crane pad stable with ECD's in place downstream of exposed soils.

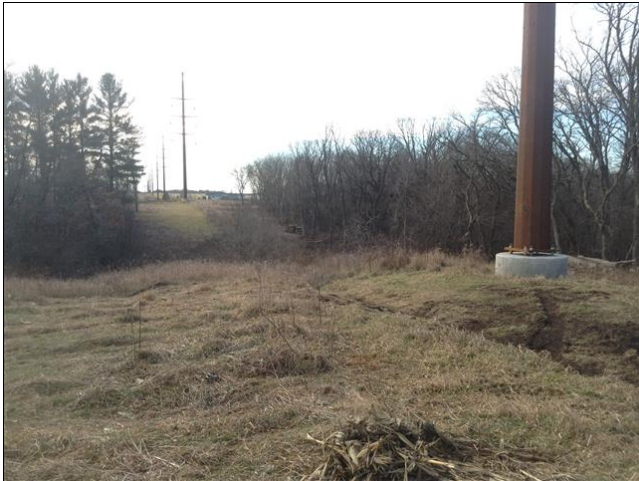
Photo – 19

Description: Heavily vegetated around wetland area. No sediment movement observed.

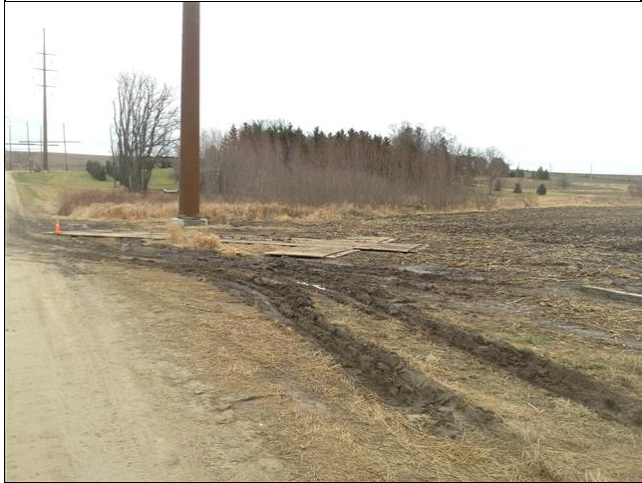
Photo – 26

Description: Some rutting was observed along the ROW from crews accessing structures in the muddy conditions.

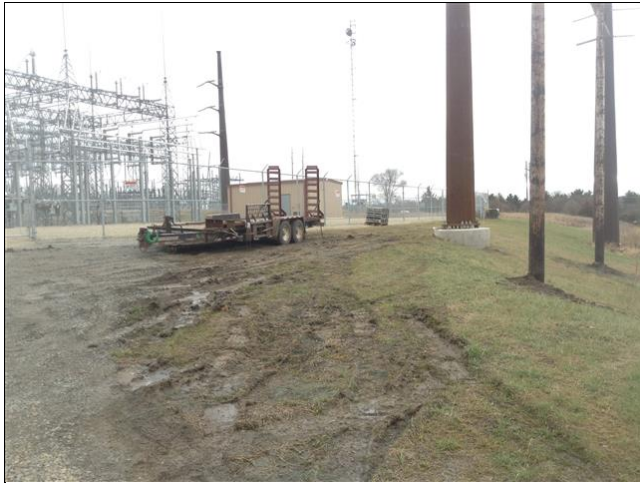
Photo – 28

Description: Some equipment caused rutting and a setback to the restoration of the substation. Issues such as this are examples of restoration work to be completed next growing season.
