**Re: Route Permit Compliance Filing: December Status Report and Complaints
Summary for Hampton-Rochester-La Crosse Transmission Line Project
PUC Docket #TL-09-1448 and the North Rochester to Chester 161 kV
Transmission Line Project PUC Docket #TL-11-800**

Environmental Monitor Monthly Report

Date: December 31st, 2015	Location: Olmsted and Goodhue Counties
Environmental Monitor(s): Andrew Welch, Andrew Wendlandt, Sarah Duke Middleton	Segment: Hampton to North Rochester
Contact #: (608) 807-9806	Site Conditions: Temperatures varied greatly throughout the month, ranging from 9 – 47 degrees F. Mild weather resulted in a rain event mid-month, and several storms dropping a wintry mix (snow/rain/ice) across the project. The ROW (Right-of-Way) remained saturated for a large portion of December, and began to freeze at the end of the month. Approximately 6-8 inches of snow covered the ROW by the end of December.

Date: December 31st, 2015	Location: Olmsted and Wabasha Counties
Environmental Monitor(s): Andrew Welch, Andrew Wendlandt, Sarah Duke Middleton	Segment: Northern Rochester to Chester
Contact #: (608) 807-9806	Site Conditions: Temperatures varied greatly throughout the month, rang

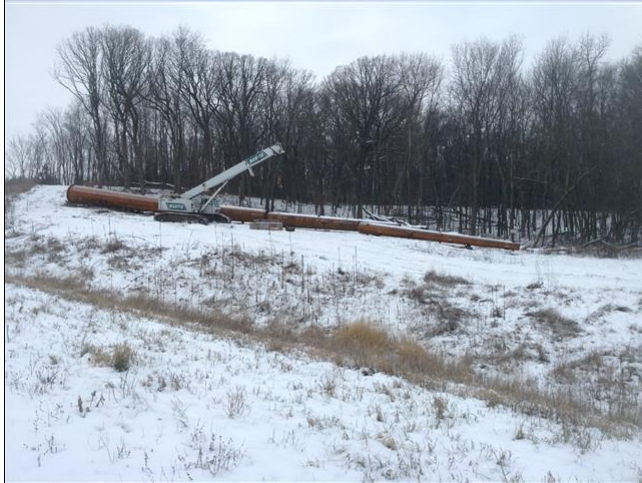
Location: STR 81

Description: Clean Harbors hasn't removed sediment from site at this time. Both the 55 gal drums and pile are on site awaiting resolution.

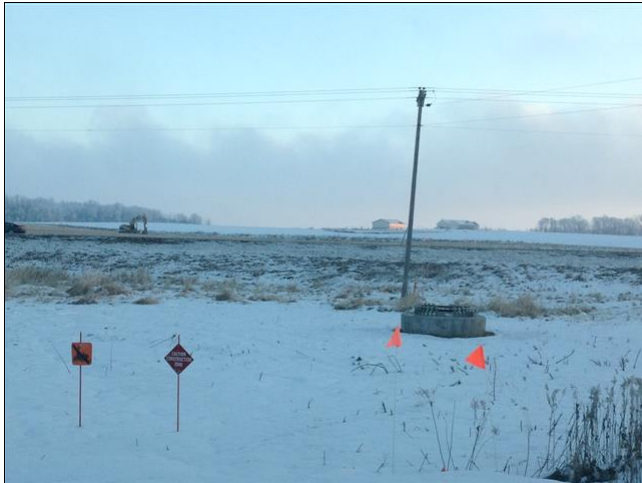
Location: STR 185

Description: ROW conditions are stable with frozen soils and several inches of snow cover. Vegetation is in place along ROW.

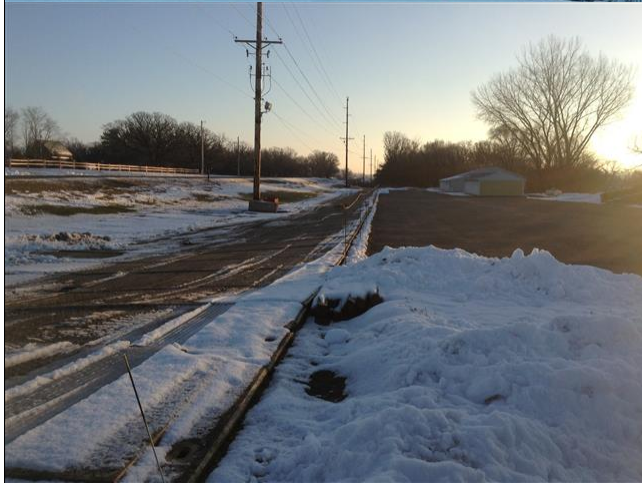
Location: STR 24

Description: Local snowmobile clubs have many trails that run along the ROW. They have been out marking the areas where crews will work to provide safety warnings to stay away from structures.

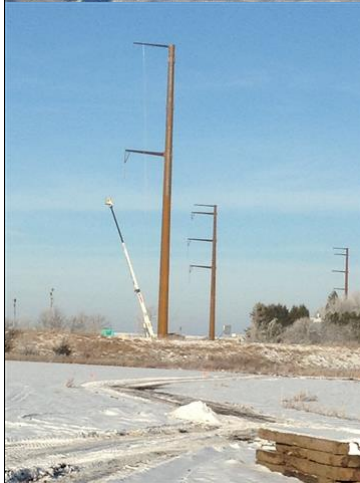
Location: STR 106

Description: Due to snow and frozen ground the hauling and framing crews have been able to ready a lot of structures along the ROW.

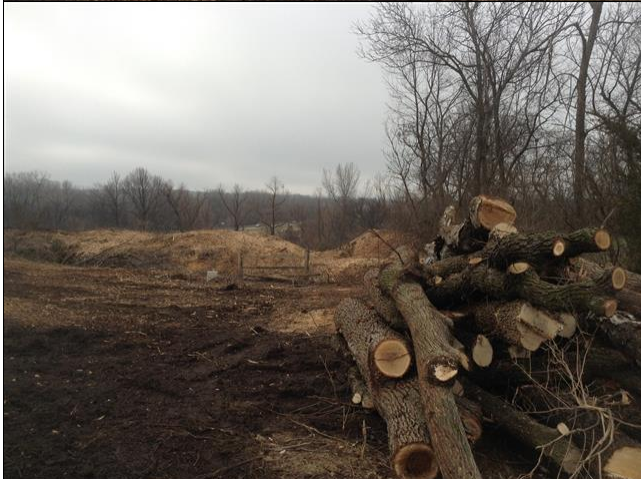
Location: STR 61

Description: Wright Tree cleared access to golf course.

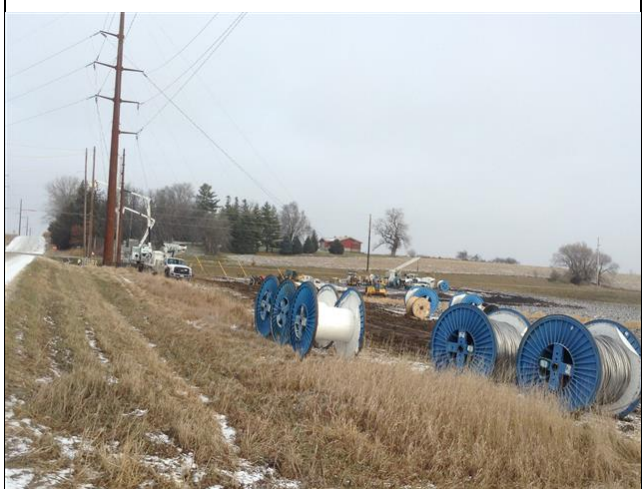
Location: STR 130

Description: (ROW) Right-of-Way is stable and remains heavily vegetated with ECDs (Erosion Control Devices) in place for stabilizing soils or protecting wetland areas.

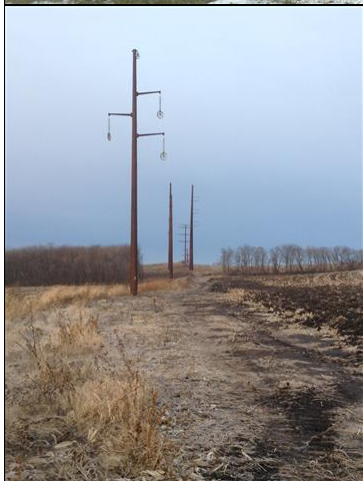
<p>Photo – 5 Date: 12/2/2015</p> <p>Location: STR 189</p> <p>Description: Crews are working on matting as much as possible to minimize rutting and compaction issues such as this example.</p>

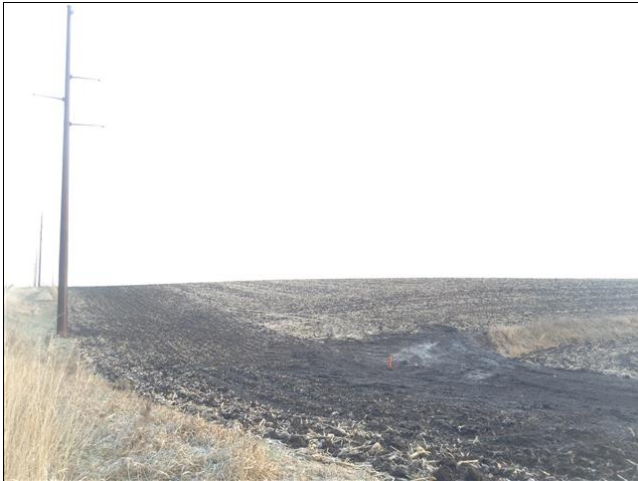
<p>Photo – 6 Date: 12/8/2015</p> <p>Location: STR 90</p> <p>Description: Structures set with pulleys awaiting wire pull. ROW is stable and wetlands protected in this area.</p>

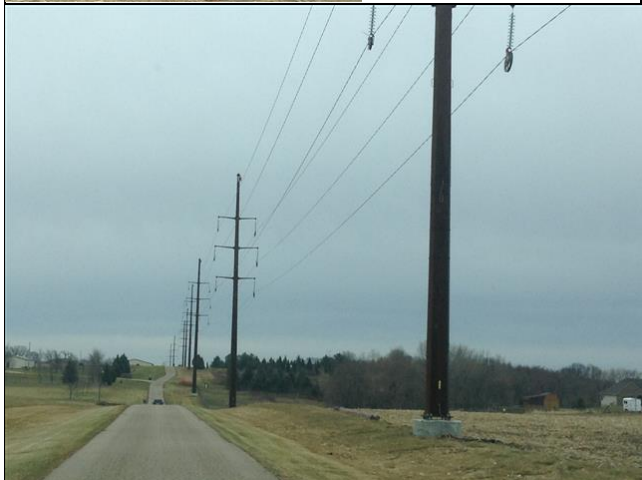
Location: STR 157

Description: Crane pad stable with ECD's in place downstream of exposed soils.

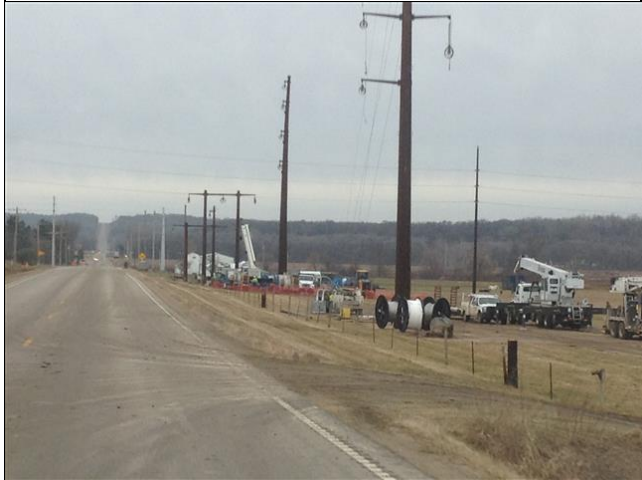
Location: STR 200

Description: Air 2 crews working on wire pull. Landing zone and equipment flagged off for safety and the ROW is in great shape.

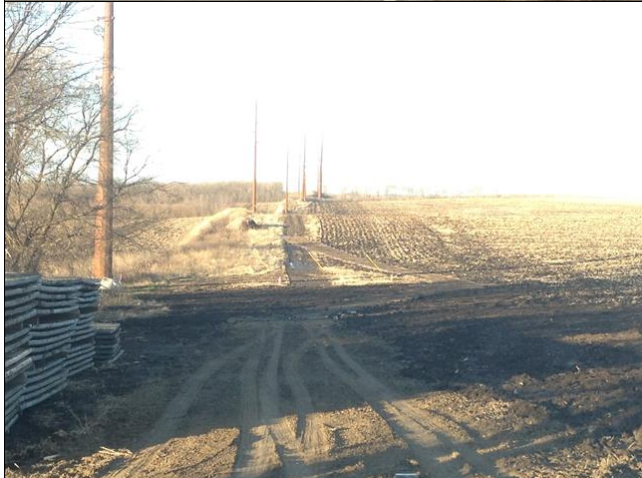
Location: STR 203

Description: Equipment staged on matting road near substation in place to minimize impact and restoration. Vegetated and stable ROW.

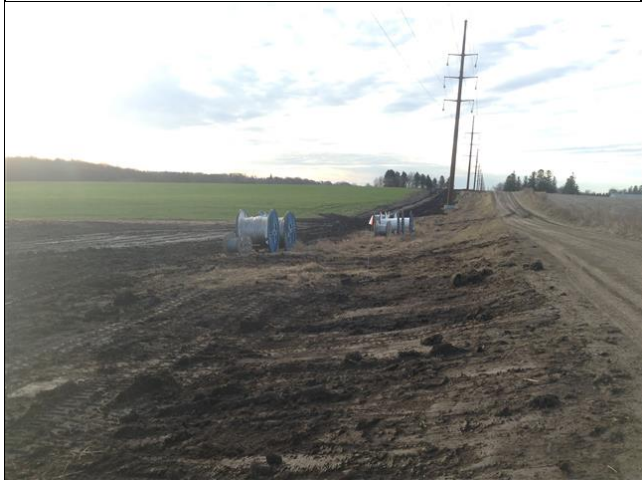
Location: STR 137

Description: ROW and wire pull area after cleanup and decompaction activities.

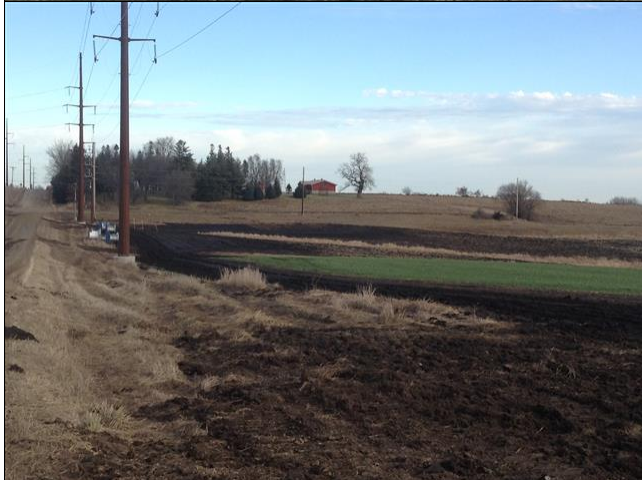
Location: STR 137

Description: Additional pictures of ROW and wire pull area after cleanup and decompaction activities.

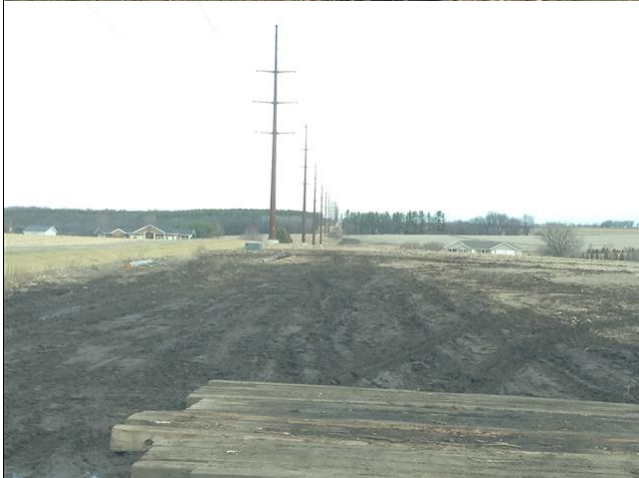
Location: STR 167

Description: Heavily vegetated around wetland area. No sediment movement observed.

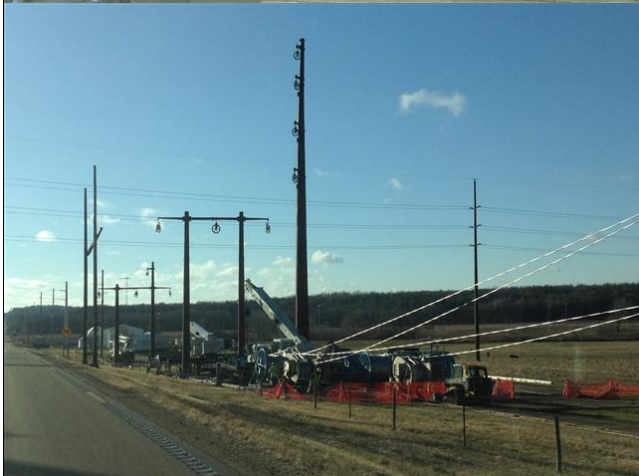
Location: STR 173

Description: ROW cleaned up after structures were setup. Wooden matting was used for access which minimized impacts.

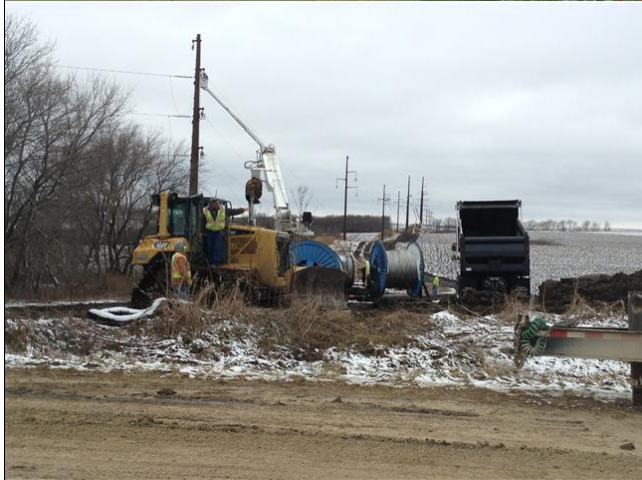
Location: STR 97

Description: Crews finishing guard structures alongside roadway.

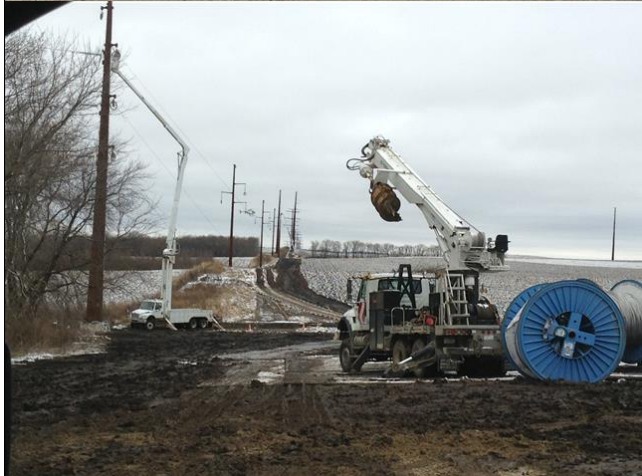
Location: STR 92

Description: Crews working on wire pull. Dahn placed additional matting and BMPs along access route and wetland areas.

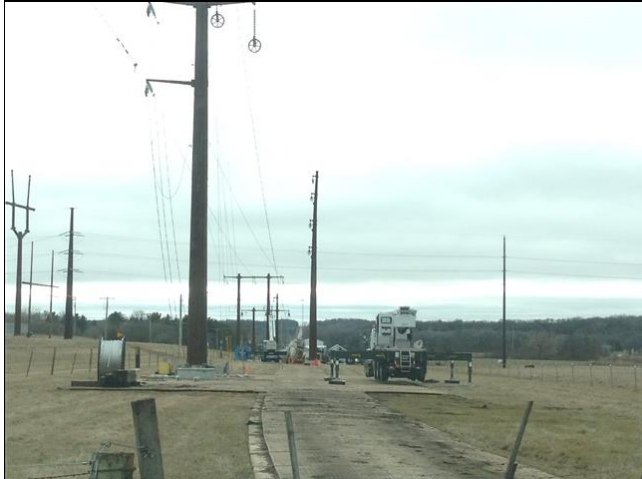
Location: STR 190

Description: Some rutting was observed along the ROW from crews accessing structures in the muddy conditions.

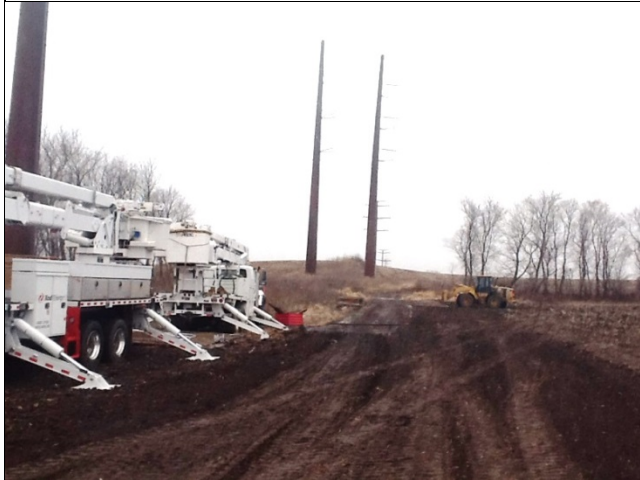
Location: Chester Substation

Description: Some equipment caused rutting and a setback to the restoration of the substation. Issues such as this are examples of restoration work to be completed next growing season.

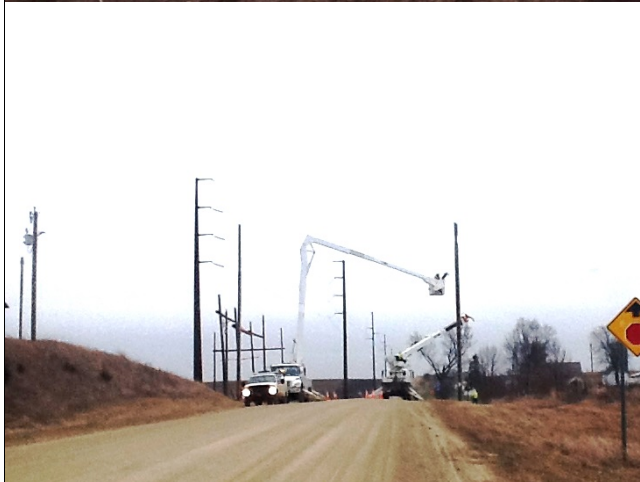
Location: STR 88

Description: Dahn Construction removing matting.
